Evaluation on Ambulance Design and Musculoskeletal Disorders Risk Factors among Ambulance Emergency Medical Service Personnel

Abstract

Keywords: Musculoskeletal disorders, Ambulance, EMS, Workers, REBA, Risks

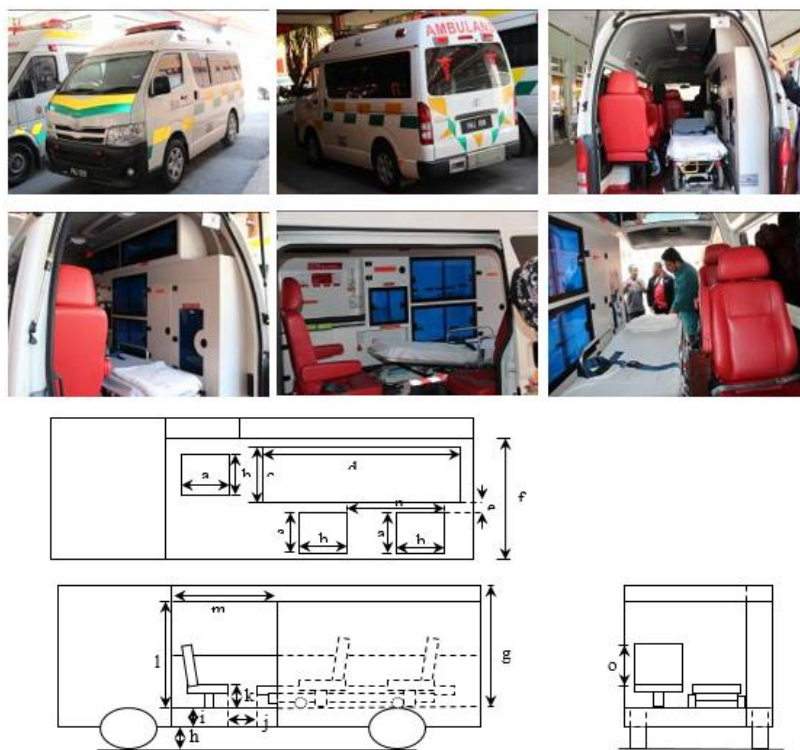
Fig. 1: Photographs and design specifications for Class B type ambulance

Referring to Fig. 1, the dimensions for the Class B ambulance are as follows: $a = 46$ cm; $b = 41$ cm; $c = 53$ cm; $d = 183$ cm; $e = 14$ cm; $f = 109$ cm; $g = 159$ cm; $h = 37$ cm; $i = 26$ cm; $j = 15$ cm; $k = 33$ cm; $l = 125$ cm; $m = 118$ cm; $n = 80$ cm; $o = 184$ cm. In terms of the ambulance's design, several problems have been identified. Based on our interview with the subjects, it seems that the dimension of the workspace for Class B ambulance is considered as narrow. This findings is in-line with past studies (15-17) found similar problem faced by many countries ambulance service is narrow patient's compartment. This is true because many currently used ambulance vehicles were converted from ice

risk in the development of the MSDs with the assumption that the ambulance is in motion while the operation activity is in progress. Photographs and design specifications for Class B type ambulance commonly used in Malaysian public hospitals are shown in Fig.1.

cream small vans, therefore the same problem of narrow space happen again and again (18). Installation of two large seats at side of the stretcher to accommodate the EMS personnel and one family member or close relative is identified to be the cause of the cramp. Furthermore, the seat cannot be adjusted or removed. Inadequate workspace may cause bumping among the emergency medical personnel and injuring the patient (19). The reason for not changing those two large seats is unknown but according to the interview, the subjects believed the reason could be due to the ambulance operating procedure that forbid any occupant to perform any major movement while the ambulance is in motion. Therefore, to prevent

Other design specifications that increase awkward position are the railing and the seat. In Class B ambulance, it is identified that the interior design of the ambulance got no hand rail. Based on the interview, this matter can cause instability towards the body during standing since most of the time the EMS personnel need to stand in order to reach for equipment or other medical items. Meanwhile, the seat used in Class B ambulance is too large and has narrowed down the workspace's dimension. Even with only a bench seat, the access towards patient in the workspace of the ambulance is still below satisfactory level (10). In addition, placement of the captain's seat for the physician is too far from the patient and it cannot be adjusted. Due to this seat placement, the EMS personnel sometimes need to bend towards the patient even though they have

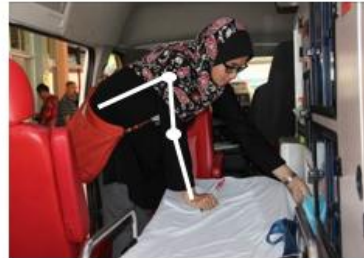
Fig. 2: EMS personnel trying to reach different parts of patient's body; the final REBA scores recorded is 9

REBA scores for Class B ambulance for the above four activities (i.e. Fig. 2-5) showed that without the hand rail, it causes unstable situation for the EMS personnel and thus increase the coupling score and activity score. These two scores have lead towards increased in the risk of developing MSDs. Activity like retrieving medical equipment or items is considered as a frequent activity done in the ambulance, this increase repetitive stretching muscle activity since the shoulder needs to be raised up above the normal raise position; it also increase repetitive twisting and

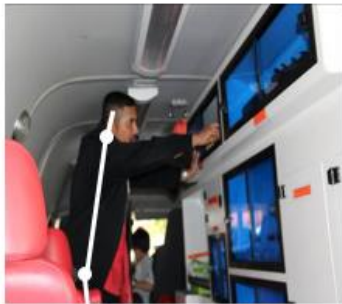
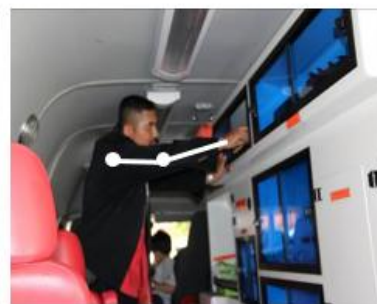
Fig. 3: EMS personnel is trying to get the medical equipment in the upper cabinet; the final REBA scores recorded is 6

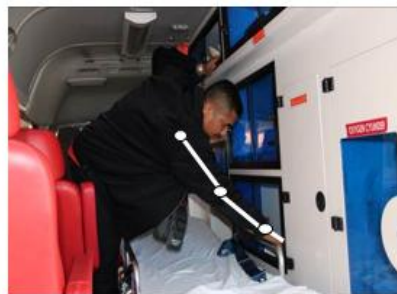
Fig. 4: EMS personnel is trying to get the medical equipment in the lower cabinet; the final REBA scores recorded is 10

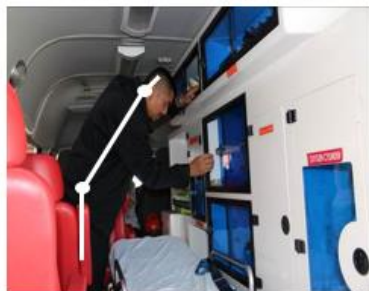
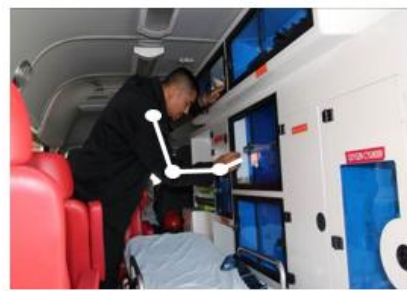
Fig. 5: EMS personnel is trying to get the medical equipment in the middle cabinet; the final REBA scores recorded is 4

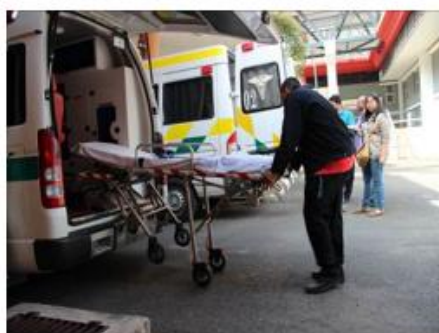
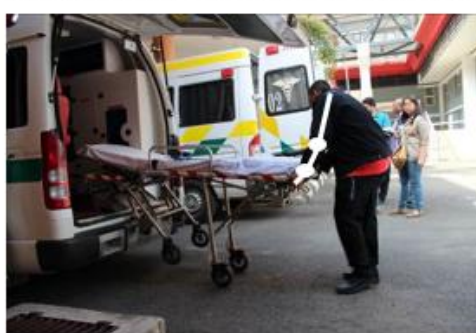
Fig. 6: EMS personnel is pulling out the stretcher from the ambulance; the final REBA scores recorded is 7

The result from Class B Ambulance; Fig. 6 showed that the ambulance EMS personnel has a medium risk of developing MSDs even with just an activity of loading out the stretcher without the patient on it. Meanwhile, the result from Fig. 7

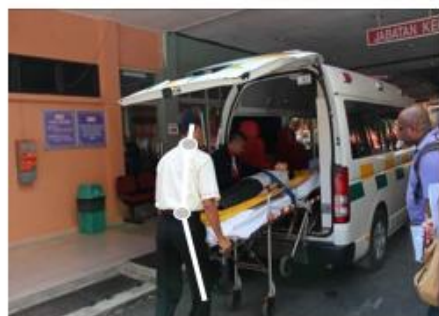
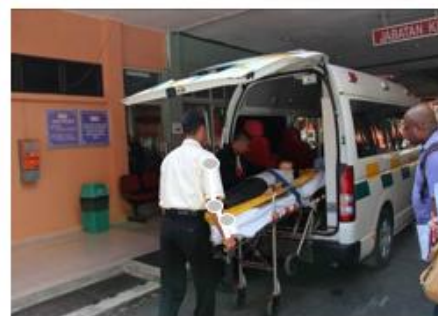
Fig. 7: EMS personnel is pushing in/out with the patient on the stretcher; the final REBA scores recorded is 4

and 8, which involves loading in the stretcher back into the ambulance showed that the risk of developing the MSDs ranges about medium to high risk even with just a small kid weighing around 40 kg.

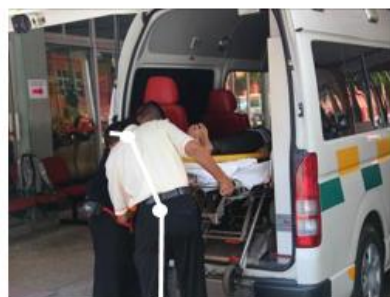
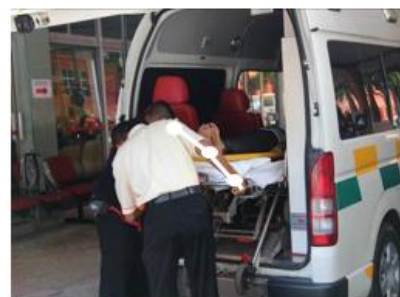
Fig. 8: EMS personnel is lifting up for pushing further the stretcher in the ambulance with the patient; the final REBA scores recorded is 8
